## Bridge Failure Points to Mechanically Frozen Pin

### Business Issue

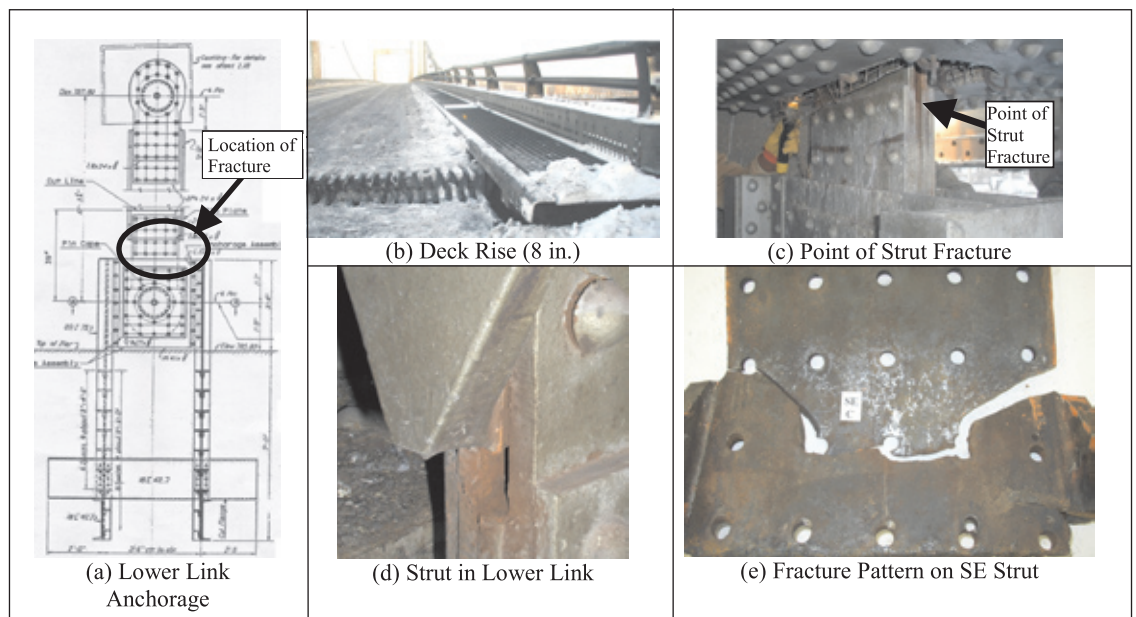
Figure 1. Link Anchorage Details, Fracture Effects and Fracture Details

On January 22, 2003, the Paseo Bridge was closed to traffic when the bridge deck was raised by eight inches as indicated in Fig. 1(b). At the time, temperatures were reported to have hit a record low of -9°F. During inspection the following day, the strut in the southeastern link anchorage assembly was found to be fractured as shown in Fig. 1(c, d, e). Field inspectors found the lower pin in the southeastern hanger was locked up and did not allow for free movement of the superstructure. As a result, the strut was subjected to both tension/compression and bending. Plausible reasons for the strut failure included overstressing, thermal contraction, fatigue, and reduction in fracture toughness associated with low temperatures. MoDOT needed to determine the actual cause and find a way to prevent similar failures in the future.

The Paseo Bridge is a 1,232-foot long, self-anchored suspension structure spanning the Missouri River. Built in 1952, it supports Interstates I-29 and I-35 as well as US Highway 71 with an average daily traffic volume of 89,000 vehicles in 2003. At each end of the bridge, two stiffening girders are tied down to a bridge pier with two vertical hangers. Each hanger consists of a lower link, a strut, and an upper link. The links are connected with the stiffening girder and the bridge pier by two 11-inch diameter pins, as illustrated in Fig. 1(a).

The root cause of the failure was overstressing of the vertical strut due to a locked up pin resulting from a bridge design that did not allow access for maintenance. The mechanical freezing of the lower link pin has been attributed to salt and sand accumulation in the lower link housing, discovered during the bridge inspection two months prior to failure. The overstressing, thermal contraction, fatigue, and reduction in fracture toughness associated with low temperatures were all real conditions, but they would not have caused the failure if the preventative maintenance had been allowed. Several relatively simple recommendations to prevent similar incidences to other bridges and the new struts installed on the Paseo Bridge include:

- Greasing the upper and lower pins during special pin inspections and maintenances to ensure continued free rotation of the struts. This would have prevented the freezing and allows for the free rotation. It is recognized that the design of the bridge had limited access to the lower link pin housing. Therefore, although the two cycles of inspection are adequate, special pin maintenance may be done over a longer time period such as every ten years.

- Partially sealing the lower housings to prevent salt and sand accumulation near the pins or using traps under the finger expansion joints to stop salt and sand debris from dropping to the lower link housing.

- Installing a problem alarm device at a cost of less than \$10,000 to remotely monitor the rotation of all four vertical struts and immediately alert officials should the pins become mechanically frozen. In light of the limited access to the lower link area, greasing pins could be costly, and this recommendation may be a practical solution in some situations.

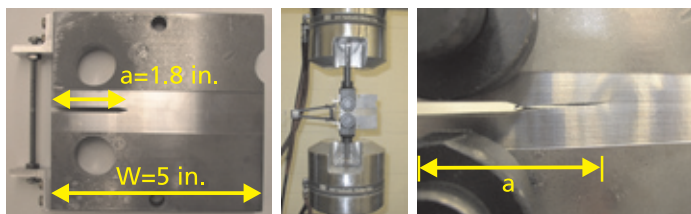
**Figure 2. Crack Growth Test: Compact Tension Specimen, Set-up and Crack Growth**

The fatigue constants necessary for the residual life prediction after 50 years of service have been determined with testing of 25 specimens. Fatigue tests on the failed strut material indicated an infinite life under normal service conditions when the strut were free to rotate, had no initial defects, or small cracks inherent to steel structures. However, initial defects often exist in steel members, especially around the coped flange of the fractured strut. Therefore, five compact tension specimens were tested as shown in Fig.2 to establish the Paris crack growth law. It was determined from the crack growth law that nearly 1,000,000 cycles (approximately 12 years) of 100% design loading or over 2,500,000 cycles of 50% design loading are required for an initial defect of 0.005 inches in the strut to propagate

to a critical length (over 1.3 or 2.4 inches) causing sudden fracture under normal loading conditions if the pin were free to rotate. Since no visual cracks were recorded during the inspection two months prior to the failure, crack propagation was unlikely the reason for the failure. On the other hand, sudden fracture occurred as a result of the mechanically frozen pin condition at the lower link of the southeastern strut due to substantially increased bending stress as previously mentioned.

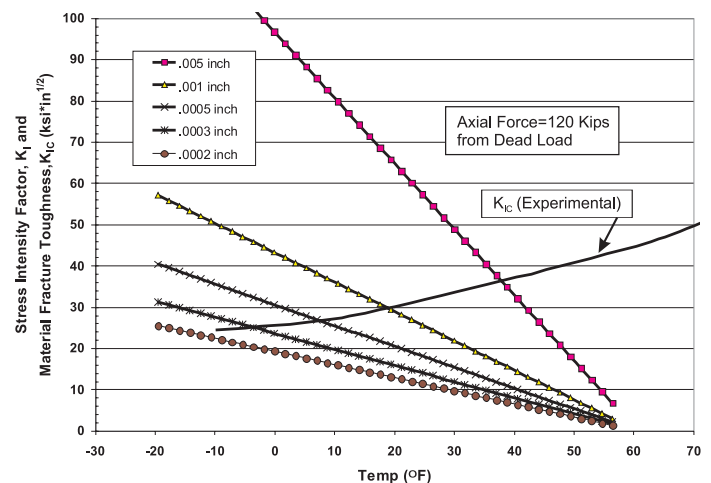
**Figure 3. Prediction Chart for Fracture of the Southeastern Strut**

To investigate the effect of temperature on the strut failure, Charpy impact testing of 45 specimens was conducted at nine temperatures so that the critical flaw size at the design stress can be determined as a function of the operating temperature from -10° to 136°F. The breaking energy of various specimens was related to the temperatures to which the specimens are exposed. The fracture toughness was then converted from the breaking energy with an empirical relation. It ranges from 24 to 110 ksi\*in<sup>1/2</sup>, as shown in part in Fig. 3 for  $K_{IC}$ .

When the fractured strut is simplified into an edge cracked plate subjected to tension and bending, the load-temperature relation established before can be transformed into the relation between the (elastic) stress intensity factor,  $K_I$ , and the temperature. The results are presented in Fig. 3 corresponding to each initial flaw size from 0.0002 to 0.005 inches. At a temperature of -10 °F, the strut may fracture suddenly since  $K_I$  is larger than  $K_{IC}$  when an initial flaw between 0.0002 and 0.0003 inches is present. It must be noted that, on one hand, the conversion equations from the load to the stress intensity factor are a non-conservative estimate to the actual condition. On the other hand, consideration of plasticity around the root of a notch in actual conditions will reduce the stress intensity factors. Therefore, numerical simulations with computer

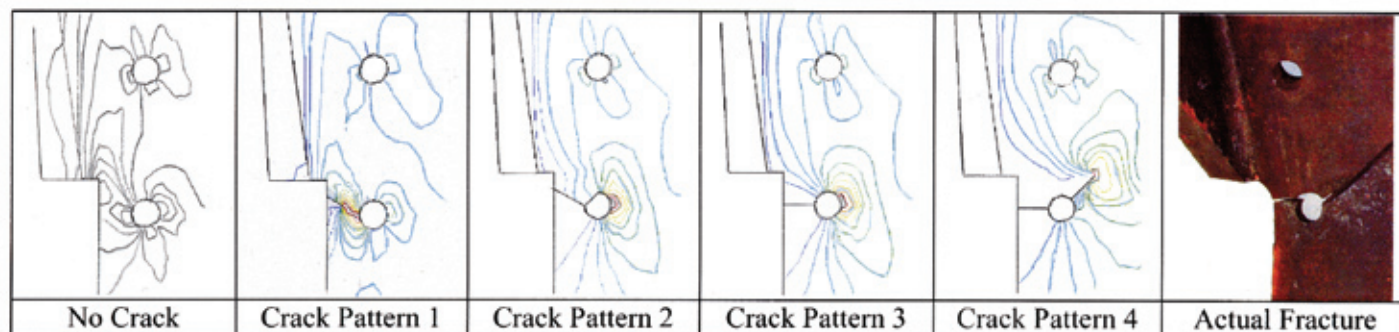
**Figure 4. Stress Contours for Crack Initiation Location Determination**

Two finite element models of the strut, a global model for the entire strut and a local model for the cracked area, were developed to better understand the stress intensity factor at the location of flange coping, the area of crack initiation in the failed strut, and the process of failure. Simulation results indicated that the strut would never have fractured even at low temperatures and with a 0.005-inch initial defect if the pin in the lower link were free to rotate. Low temperature makes the strut material behave more brittle with low fracture toughness and is thus a secondary contributor to the fracture of the strut after the pin was mechanically frozen. The load transferred through the web of the strut is likely 50% of design loading as supported by the fact that the strut did not fracture under the combined dead plus live load and thermal effect at a temperature of higher than -10°F during the bridge inspection in November, 2002. The initial defect (crack) in the coping flange area of the failed strut seems more than 0.001 inches.

a series of local models with various initial crack lengths were established. Each model was analyzed for the same load case. When there are no crack and cracks of various sizes (Crack Pattern 1 through 4), the stress contours are shown in Fig. 4. It is observed from Fig. 4 that crack is likely initiated near the flange coping area due to high stress concentration and propagated towards the closest hole. To further see the propagation of an initial crack, two additional models with a crack length of 0.5 in. for Crack Pattern 1 and 1.1 in. for Crack Pattern 2, respectively, were analyzed. As a result of the previous cracks, the maximum stress occurs in the opposite side of the hole near the flange coping area. To understand how sensitive the location of the maximum stress, the third crack pattern was introduced. By comparing Crack Pattern 2 and Pattern 3, one can see that the locations of the maximum stress identified from the two models are practically the same. To finish up the analysis for crack propagation, the fourth crack pattern was created. By comparing Crack Pattern 4 with the actual fracture pattern, also shown in Fig. 4, it is observed that the models accurately predict the crack initiation and propagation locations of the actual damage pattern.
